# PERFORMANCE OF CONDUCTIVE PRE-PRIMERS APPLIED ON GALVANIZED STEEL SHEETS FOR AUTOMOTIVE BODIES<sup>(\*)</sup>

D. Santos<sup>(1) (\*)</sup>, H. Raminhos<sup>(1)</sup>, M. Costa<sup>(1)</sup>, T. Diamantino<sup>(1)</sup> and F. Goodwin<sup>(2)</sup>

**Key Words:** Automotive, Conductive Pre-Primers, Steel Sheets, Metallic Zinc Coatings

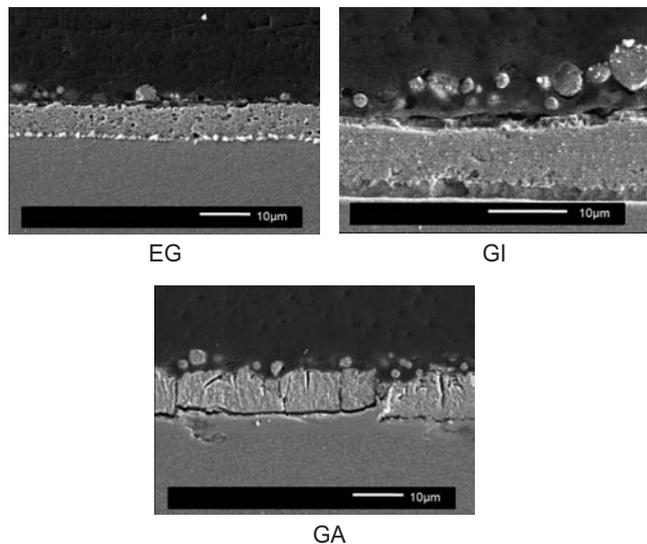
Fig. 1 – Appearance, observed by SEM, of samples obtained by cross section of primer 1 applied on electrogalvanized, hot dip galvanized and galvanized substrates.

Tables 1 to 3 contain the mean thickness values of metallic coatings and primers. For primer 1, the evaluation of primer thickness from SEM micrographs was not feasible, due to difficult observation of the interface between the primer and the resin used for the preparation of cross section samples (Fig. 1). For the electrophoretic primer, due to its difficult removal by pickling, the individual thickness was measured on SEM micrographs (Fig. 2 and 3).

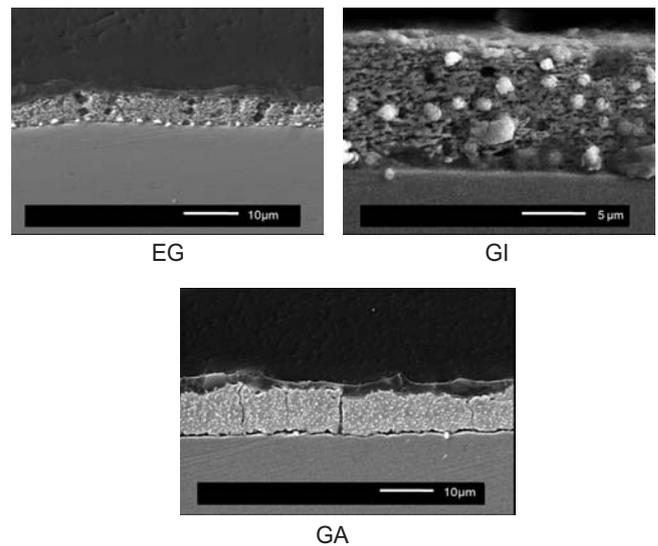
Fig. 2 – Appearance, observed by SEM, of samples obtained by cross section of primer 2 applied on electrogalvanized, hot dip galvanized and galvanized substrates.

\*\* From SEM micrographs of samples obtained by cross section (Fig. 2).

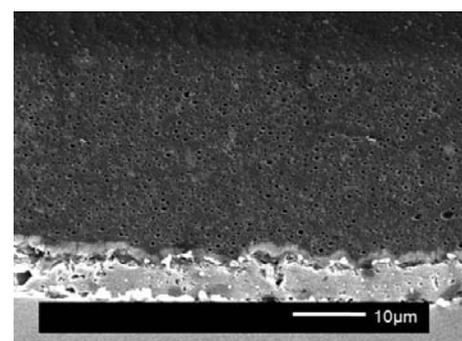
Fig. 3 – Appearance, observed by SEM, of sample obtained by cross section of electrophoretic primer system applied on electrogalvanized substrate.

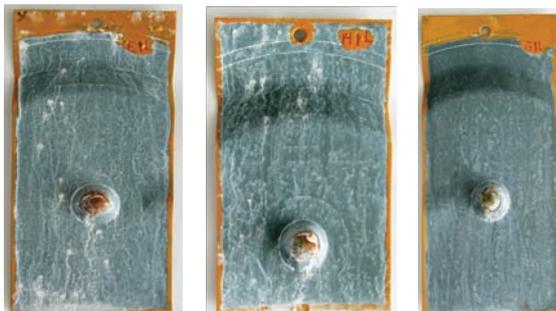
Results of exposure to 10 corrosion cycles according to the VDA-procedure 621-415 [7], of primer 1 submitted to cupping and "pie pan" deformations

Area	EG + Primer 1	GI + Primer 1	GA + Primer 1
General overview	Considerable Zn corrosion	Considerable Zn corrosion	Moderate Zn corrosion
Pie pan	Considerable Zn corrosion	Considerable Zn corrosion	Moderate Zn corrosion
Cupping area	Zn corrosion with dripping; considerable Fe corrosion	Zn corrosion with dripping; moderate Fe corrosion	Zn corrosion with dripping; slight to moderate Fe corrosion

The results of visual inspections performed on the primers applied on the three substrates, with "pie pan" and cupping deformations, submitted to 10 corrosion cycles according to the VDA-procedure 621-415 [7] are presented in Tables 6 to 8. These tables have annexed the corresponding pictures. Results of samples with stone chipping damage, submitted to cyclic corrosion test are presented in the same way in the Tables 9 to 11.

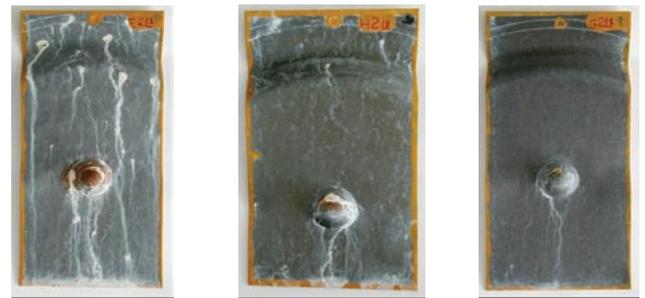
**Table 7**

Results of exposure to 10 corrosion cycles according to the VDA-procedure 621-415 [7], of primer 2 submitted to "pie pan" and cupping deformations

Area	EG + Primer 2	GI + Primer 2	GA + Primer 2
General overview	Considerable Zn corrosion	Slight Zn corrosion	Moderate Zn corrosion
Pie pan	Considerable to severe Zn corrosion; Fe corrosion in the Zn spots	Slight to moderate Zn corrosion	Moderate Zn corrosion
Cupping area	Considerable Zn corrosion; severe Fe corrosion	Considerable Zn corrosion; considerable Fe corrosion	Zn corrosion products; slight to moderate Fe corrosion

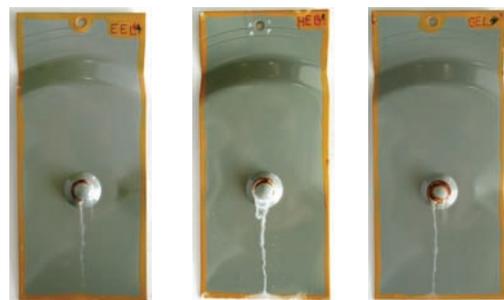
**Table 8**

Results of exposure to 10 corrosion cycles according to the VDA-procedure 621-415 [7], of electrophoretic primer submitted to cupping and "pie pan" deformations

Area	EG + ELPO	GI + ELPO	GA + ELPO
General overview	No change	No change	No change
Pie pan	No change	No change	No change
Cupping area	Moderate Zn corrosion in the rupture area; moderate Fe corrosion; blisters 4(S3)	Considerable Zn corrosion; slight Fe corrosion; blisters 5(S3)	Slight Zn corrosion in the rupture area; considerable Fe corrosion; blisters 4(S3)

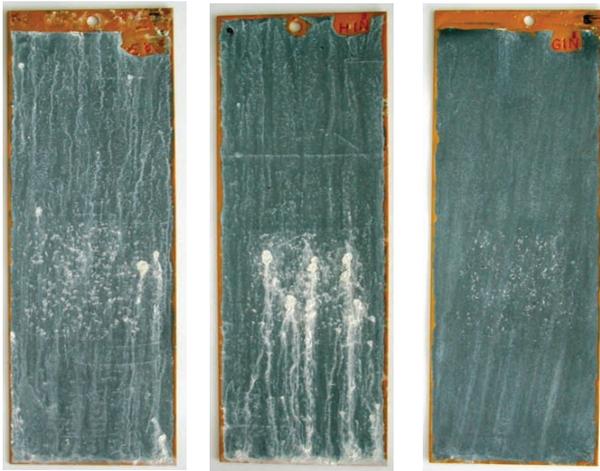
**Table 9**

Results of exposure to 10 corrosion cycles according to the VDA-procedure 621-415 [7], of primer 1 submitted to stone chipping test

Area	EG + Primer 1	GI + Primer 1	GA + Primer 1
General overview	Moderate to considerable Zn corrosion	Moderate Zn corrosion	Slight Zn corrosion
Stone chipping area	Severe Zn corrosion; moderate Fe corrosion	Severe Zn corrosion; moderate Fe corrosion	Slight Zn corrosion; slight Fe corrosion

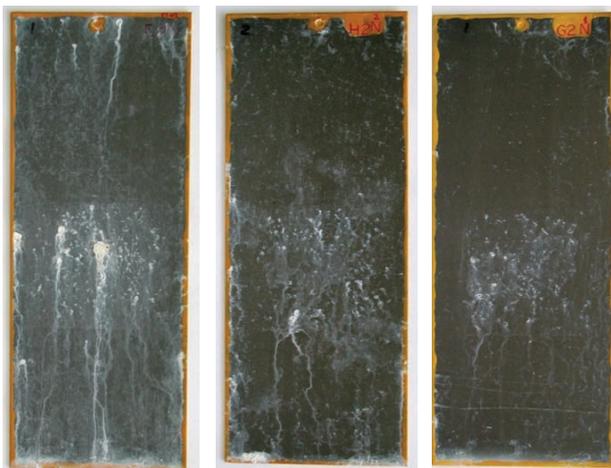
**Table 10**

Results of exposure to 10 corrosion cycles according to the VDA-procedure 621-415 [7], of primer 2 submitted to stone chipping test

Area	EG + Primer 2	GI + Primer 2	GA + Primer 2
General overview	Slight Zn corrosion	Slight Zn corrosion	Slight Zn corrosion
Stone chipping area	Moderate Zn corrosion; slight Fe corrosion	Moderate Zn corrosion; slight Fe corrosion	Slight Zn corrosion; slight Fe corrosion

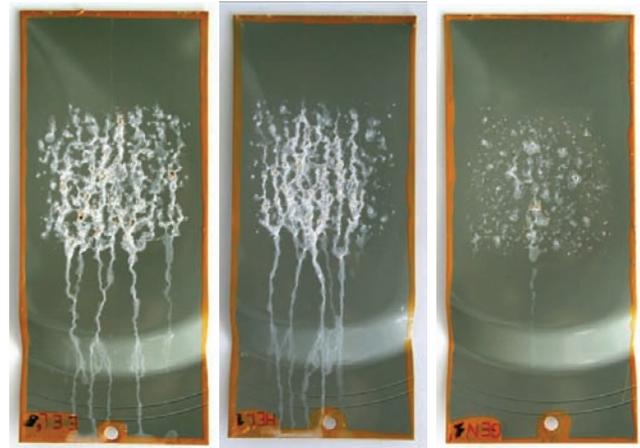
**Table 11**

Results of exposure to 10 corrosion cycles according to the VDA-procedure 621-415 [7], of electrophoretic primer submitted to stone chipping test

Area	EG + ELPO	GI + ELPO	GA + ELPO
General overview	No change	No change	No change
Stone chipping area	Severe Zn corrosion; Fe corrosion	Severe Zn corrosion; moderate Fe corrosion	Slight Zn corrosion; slight Fe corrosion

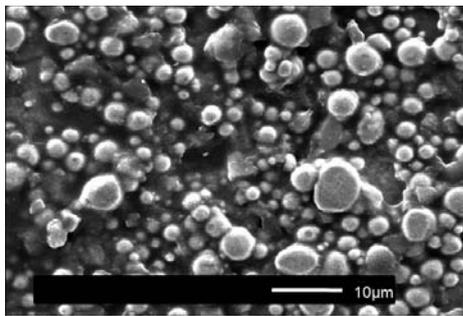
Fig. 4 – Aspect, observed by SEM, of the surface of primer 1 prior to cyclic corrosion test.

Iron corrosion was not observed on the surface without damage, of the three primers applied on the three substrates. More or less zinc corrosion appeared on the surface of primers 1 and 2. Primer 1 is a zinc rich primer (Fig. 4), and after cyclic corrosion test by SEM, on its surface acicular aggregates and plate-like hexagonal crystals were observed (Fig. 5). Chloride was detected by EDS mainly on the plate-like hexagonal crystals. X-ray diffraction (XRD) studies previously performed on zinc rich primers exposed in salt spray cabinet [13] showed that this crystal correspond to the trigonal compound  $Zn_5(OH)_8Cl_2 \cdot 2H_2O$ . In these studies previously performed,  $Zn_5(OH)_6(CO_3)_2$  was identified by XRD as the major component of acicular aggregates in agreement with the results of van Eijnsbergen [14] and others [15]. Hydroxyl chloride,  $Zn_5(OH)_8Cl_2 \cdot 2H_2O$ , can also be present in acicular aggregates.

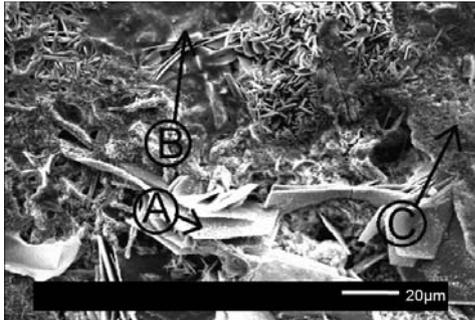
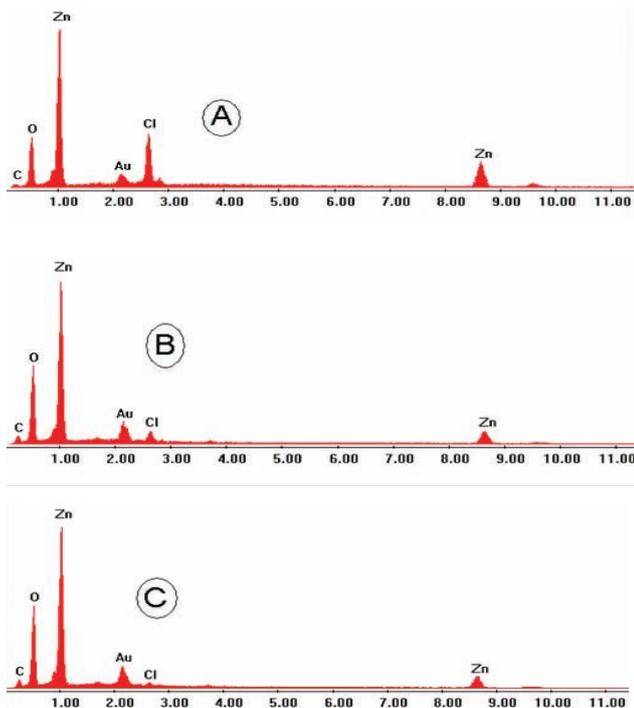
Fig. 5 – Aspect, observed by SEM, of surface of primer 1 applied on hot-dip galvanized steel, after cycle 15 plus 3 weekend cycles according to SAE J2334 procedure [11] and corresponding EDS spectra.

On the surface of primer 1 submitted to cyclic corrosion test, thin acicular crystals and plate-like hexagonal crystal were observed by SEM. Aggregates of acicular crystals can correspond to basic zinc carbonate  $[Zn_5(OH)_6(CO_3)_2]$  and plate-like hexagonal crystal to zinc hydroxychloride hydrate  $[Zn_5(OH)_8Cl_2 \cdot 2H_2O]$ . Humidity and temperatures conditions, and the relative polarizability of  $OH^-$ ,  $CO_3^{2-}$  and  $Cl^-$  ions, may be responsible for the mechanisms of formation of the different types of zinc corrosion products observed. Basic zinc carbonate and other zinc compounds can be replaced by increasingly dense plate-like structures of basic zinc chloride (pseudo-hexagonal crystals).

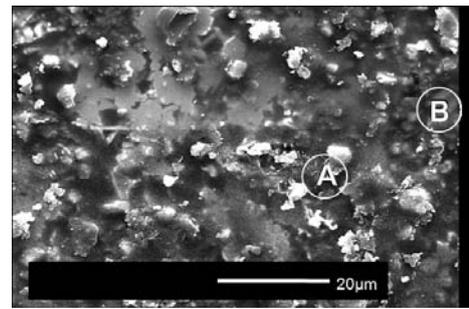
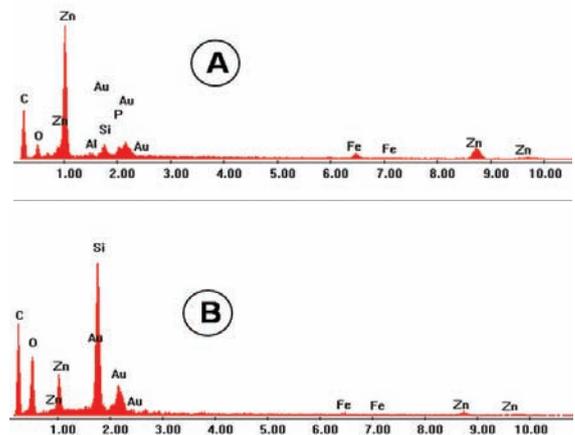
On the surface of unexposed primer 2, with a very low thickness, it was possible to detected, by EDS, the presence of zinc from the substrate (Fig. 6).

Fig. 6 – Aspect, observed by SEM, of surface of primer 2 without exposure and corresponding EDS spectra.

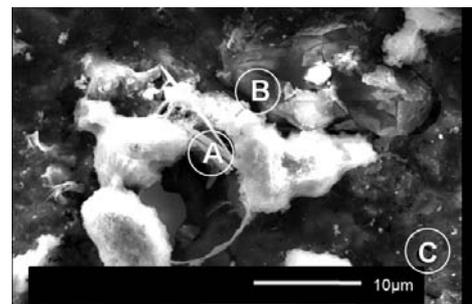
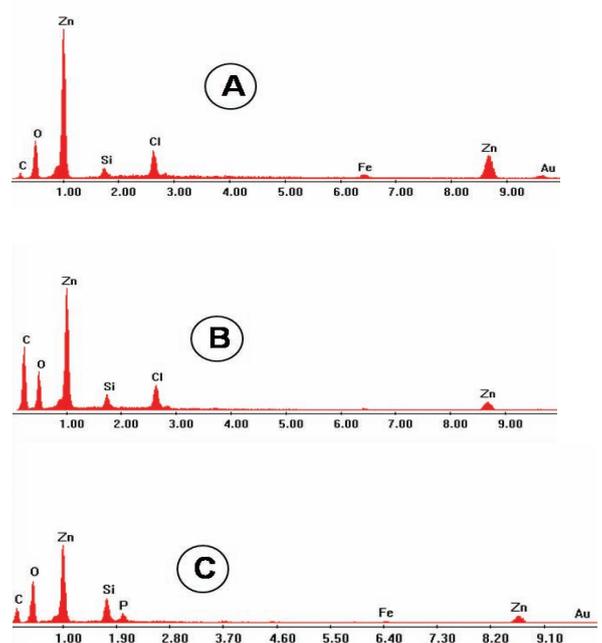
After a short exposure time, zinc corrosion products were visible, which arose through the pores of the coating, as acicular aggregates and plate-like hexagonal crystals (Figure 7).

Fig. 7 – Aspects, observed by SEM, and corresponding EDS spectra of primer 2 applied on galvanized steel after 5 cycles exposure [7].

After 5 cycles exposure, it was possible to see by SEM, zinc corrosion products on the surface of primer 2 arising from the pores of the paint coating, in the form of acicular aggregates and of plate-like hexagonal crystals. As in the case of primer 1, the major compound of acicular aggregates should be basic zinc carbonate (hydrozincite) and the plate-like hexagonal crystals can correspond to zinc hydroxychloride hydrate.
