EVALUATION OF CORROSION BEHAVIOUR OF ORGANIC-COATED STRUCTURED SHEET METALS<sup>#</sup>

E. Kornienko<sup>(1)(\*)</sup>, R. Ossenbrink<sup>(1)</sup> and V. Michailov<sup>(1)</sup>**Abstract**

In the present paper the corrosion behaviour of organic-coated structured sheet metals was analysed. These materials are innovative and with three-dimensional geometry. The major advantage of this sheet metal is a higher stiffness in comparison with a smooth sheet.

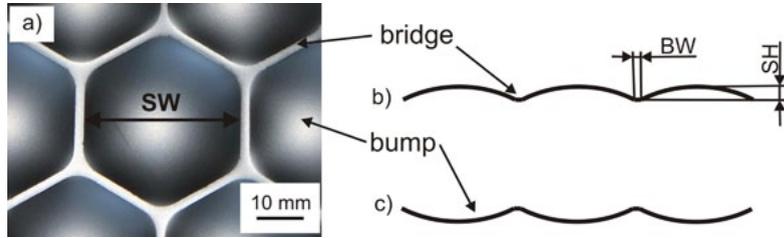
**Fig. 1** - Structured sheet metal overview (a) and geometrical characteristics; b) "positive" structure location and c) "negative" structure location.

The investigated structured sheet metal with the hexagonal geometry was manufactured by the hydroforming process (Fig. 1 (a)). The equipment for the structuring process consists of a rigid die and a gummy membrane. The sheet metal is formed by water pressure in the membrane of 50 bar. During hydroforming, the sheet metal surface that was in contact with the die formed the "positive" structure location (Fig. 1 (b)). The "negative" structure location of the sheet surface was in contact with the gummy membrane (Fig. 1 (c)). The main dimensions of the produced structure elements are the 33 mm structure

width (SW), 3.1 mm structure high (SH) and 2 mm bridge width (BW) between regular bumps (Fig. 1).

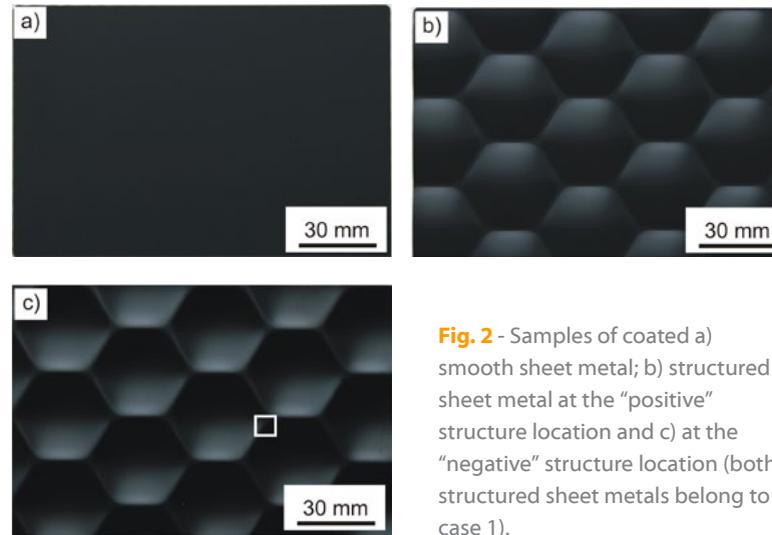
**Fig. 2** - Samples of coated a) smooth sheet metal; b) structured sheet metal at the "positive" structure location and c) at the "negative" structure location (both structured sheet metals belong to case 1).

The samples for the corrosion test with dimensions of (150x100x0.7) mm are illustrated in Fig. 2. The samples were visually inspected after hydroforming in order to determine the coating surface quality.

The results in the case 1 show that there are no geometry effects on the corrosion properties. The coating system has a good adhesion with the structured sheet metal surface. The reason for the high corrosion in the case 2 is the deformation of the coating by the hydroforming process (see Fig. 2). In spite of small plastic strains by the structuring [16], the coating was damaged at both structure locations. The corrosion protection is significantly reduced. The positions with the highest corrosion are the most strained areas. These are bumps at the "positive" structure location and bridges at the "negative" structure location. The following mechanisms of the coating degradation can be assumed. At the "positive" structure location the main reasons are the

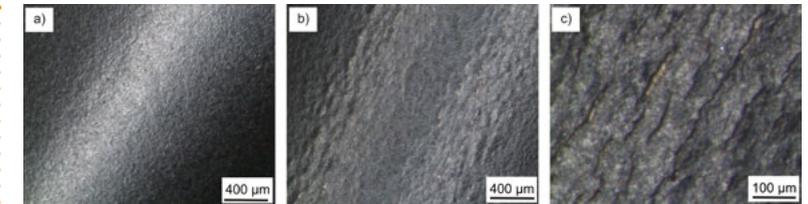
**Fig. 3** - Bridge area extracted from marked position in Fig. 2 (c): a) structured before coating process (case 1); b) and c) structured after coating process (case 2).

After the structuring process small coating damages were observed in the bridge area at the "negative" structure location (Fig. 3). The defects are directed along the bridge. At the "positive" structure location no defects were detected.

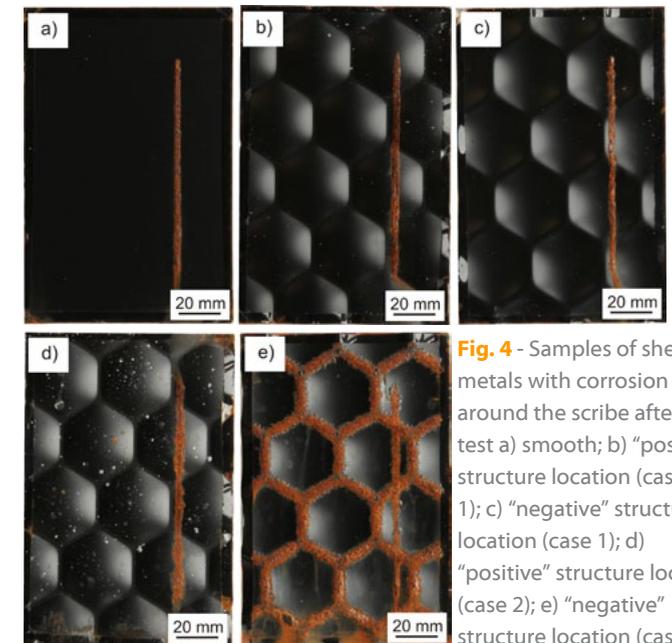
**Fig. 4** - Samples of sheet metals with corrosion around the scribe after the test a) smooth; b) "positive" structure location (case 1); c) "negative" structure location (case 1); d) "positive" structure location (case 2); e) "negative" structure location (case 2).

Fig. 4 demonstrates the scribed samples after the corrosion test. The visual analysis of the samples surfaces shows no difference between the smooth and structured (case 1) sheet metals at both structure locations (Fig. 4 (a), (b), (c)). The surfaces of some samples have a few very small defects with the 0.05 mm<sup>2</sup> area. The width of the corrosion around the scribe is also similar to the smooth and structured sheet metals.

In the case 2 (structuring after coating) a significant damage could be seen after the test (Fig. 4 (d), (e)). The "positive" structure location shows a few corrosion defects (rust) and many blisters especially in the bump top area. The degree of blistering is 3 (S2) according to DIN EN ISO 4628-2. The bridge area of the structured sheet metal at the "negative" structure location corroded completely. The corrosion around the scribe at both structure locations is slightly wider than that of the smooth sheet metal.

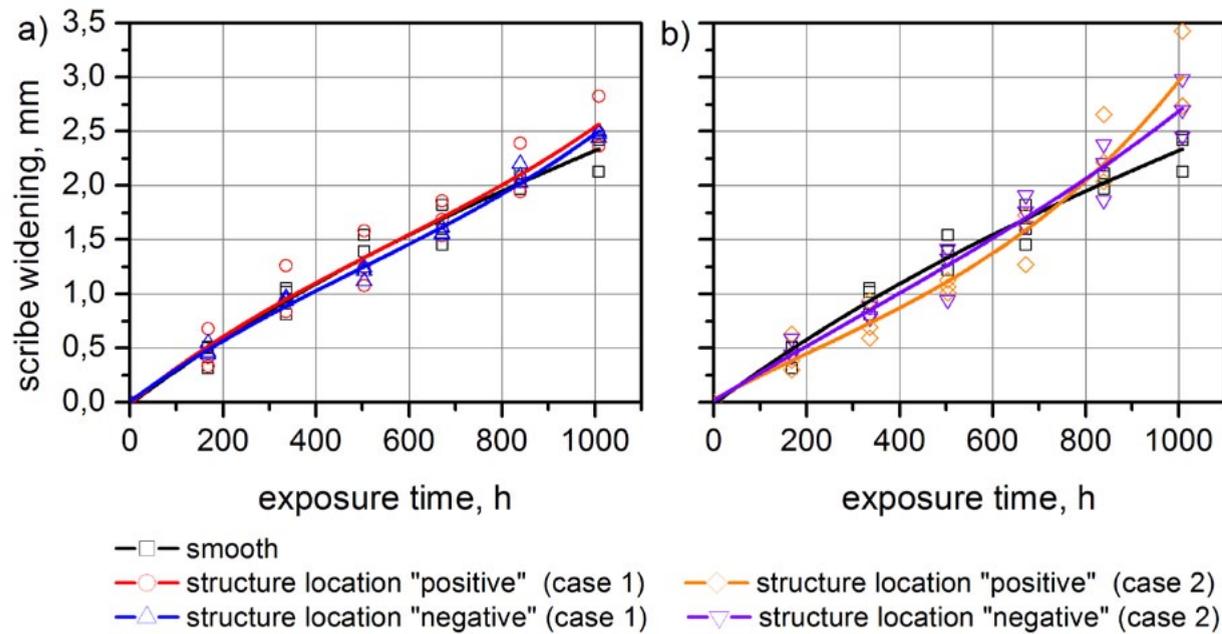
Fig. 5 - Evaluation of corrosion around the scribe during the test for the smooth and structured sheet metals: a) case 1; b) case 2.

Fig. 5 (a) illustrates the change of the corrosion around the scribe width for the smooth and structured (case 1) sheet metals. The rate of the corrosion development is nearly constant and equal for all sheet metals. The widening of the corrosion around the scribe is approximately 2.5 mm.

Fig. 5 (b) shows the progress of the corrosion around the scribe

width for the smooth and structured sheet metals in the case 2. The corrosion around the scribe width changes less for the structured than for the smooth sheet metals until 672 h of exposure time. After 672 h the values are equal for the smooth and structured sheet metals at the "negative" structure location. The values of the corrosion around the scribe widening for the structured sheet metal are higher after 840 h than these for the smooth sheet metal. The maximal increase of the corrosion around the scribe is 2.4, 3.4 and 3.0 mm for the smooth and structured sheet metals at the "positive" and "negative" structure locations respectively. The reason for the less widening of the corrosion around the scribe for the structured sheet metal within the first 4 cycles is the blistering around the scribe, especially at the "positive" structure location. After 4 weeks some blisters opened and the corrosion around the scribe width increased.

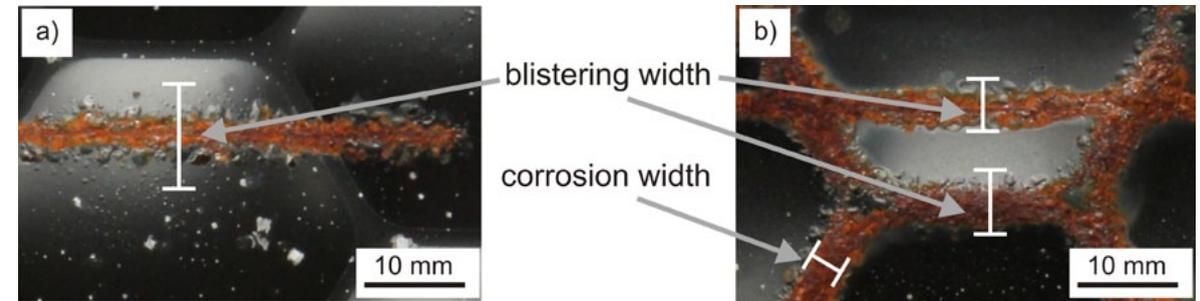
Fig. 6 - Blistering around the corrosion around the scribe at the structured sheet metal (case 2): a) "positive" structure location; b) "negative" structure location.

The blistering around the corrosion around the scribe for the structured sheet metals (case 2) at the "positive" (a) and "negative" (b) structure locations is presented in Fig. 6. At the "positive" structure

location clearly more blisters were observed than at the "negative" structure location. The maximal blister dimension around the corrosion around the scribe is approximately 1 mm for both structure locations. At the "positive" structure location the blistering area is significant. The blister dimensions are getting smaller with increasing distance to the scribe.

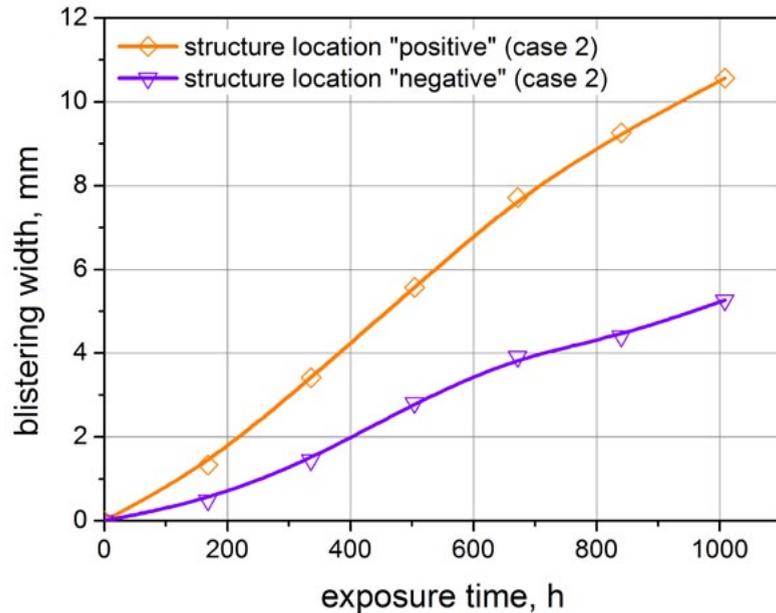
Fig. 7 - Development of blisters around the corrosion around the scribe for the structured sheet metal (case 2).

The propagation of blistering around the corrosion around the scribe during the test is shown in Fig. 7. At the "negative" structure location the development of blisters progresses slower than at the "positive" structure location. The width of the blistering area is also smaller at the "negative" structure location. The divergence between the curves is increasing with advancing exposure time.

The area of blistering around the corrosion around the scribe at the "positive" structure location is approximately two times larger in comparison with the "negative" structure location for all test periods. The width of the blistering area is 10.6 mm at the "positive" structure location and 5.3 mm at the "negative" structure location at the end of the test. This leads to the conclusion that the coating adhesion after the structuring process is worse at the "positive" structure location

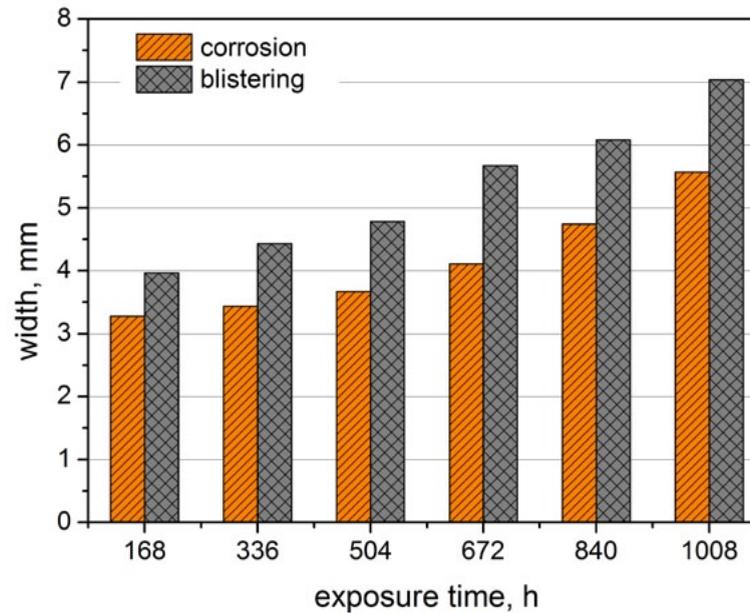
Fig. 8 - Corrosion and blistering in the bridge area of the structured sheet metals at the "negative" structure location (case 2) after different times of corrosive environment exposure.

A lot of blisters developed around the damaged coating in the bridges of the structured sheet metal (case 2) at the "negative" structure location. Fig. 8 illustrates the progress of the corrosion and blistering width. After the first cycle the corrosion area width is already 3.3 mm. The blistering width is approximately 4 mm. With the exposure time the width of the blistering and corrosion areas increase proportionally. At the end of test the width of the corrosion area is 1.7 times and blistering area 1.8 times larger in comparison with this after 168 h of test.

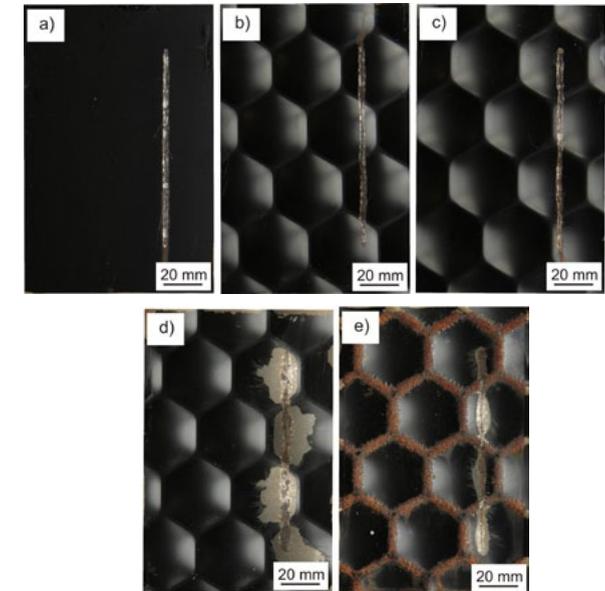
Fig. 9 - Samples of the sheet metals after removal of coating around the scribe a) smooth; b) "positive" structure location (case 1); c) "negative" structure location (case 1); d) "positive" structure location (case 2); e) "negative" structure location (case 2).

The delamination area was assessed after removal of coating around the scribe. Fig. 9 illustrates clearly the difference between the smooth

and structured sheet metals in the case 1 and case 2. It was possible to remove the coating around the scribe at the smooth and structured (case 1) sheet metals only in the corrosion area. The corrosion and delamination areas are equal. For the structured sheet metal in the case 2 the delamination area is larger than the corrosion area. Fig. 9 (d) and 9 (e) shows that the coating delamination progresses in the bump area. The coating in the bridge area at the "positive" structure location and in the area near the bridge at the "negative" structure location has high adhesive. The probable reason is the compressive stress in this areas during the structuring which did not impair the coating.

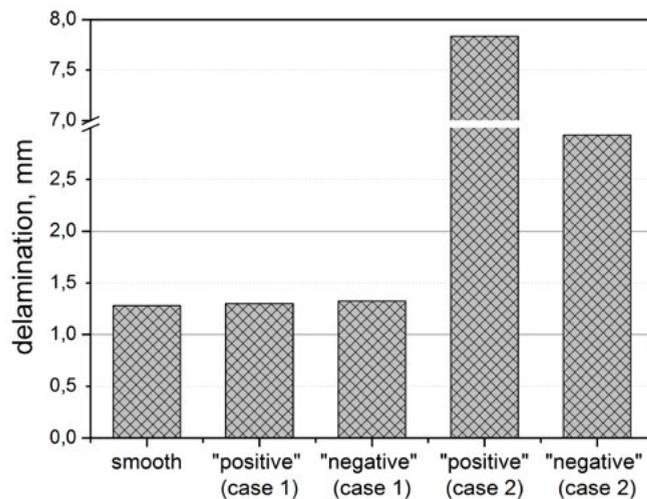
Fig. 10 - Coating delamination width on the specimen surfaces.

Fig. 10 demonstrates the delamination width for all investigated cases. It is evident that the structured sheet metals in the case 2 at the "positive" structure location have the biggest coating delamination width. The values for the smooth and structured sheet metals in the

case 1 are approximately identical. For the structured sheet metals in the case 2 the values are 7.8 and 3.0 mm at the "positive" and "negative" structure locations respectively.
