Corrosion Protection of Hot Dip Galvanized Steel in Mortar

Rita M. Figueira,^{a,b,*} Elsa V. Pereira,^a Carlos J.R. Silva,^b Maria M. Salta^a

^a LNEC – Laboratório Nacional de Engenharia Civil, Lisboa, Portugal

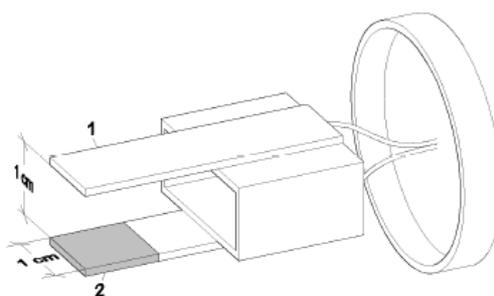
Figure 1. Schematic representation of electrochemical system developed for assess coating performance through monitoring of i_{gal} . Legend: 1. Stainless steel counter electrode (CE); 2. HDGS coated working electrode (WE), with OIH gel deposit represented by a grey zone.

To assess the reliability of the electrochemical system, macrocell current density (i_{gal}) [25] measurement was performed using a system based on two electrodes (parallel rectangular metal plates with 5.0x1.0x0.1 cm), as shown in Fig. 1. The working electrode (WE) was a HDGS plate, also with two cm² of area, and coated as described in section “Preparation of HGDS coated samples”. The grey area in Fig. 1 represents the OIH coating on HDGS. The counter electrode (CE) was a stainless steel (SS, type 316L) plate with an active surface section of 2 cm². The edges of both of the electrodes plates, as well the non-active area and connecting zones were protected with a two-component epoxy resin (Araldite®). The set of the two electrodes was fixed in plastic lids that fit in a 100 mL polyethylene flask (Normax). For comparison purposes, cells using a HDGS WE without any OIH coating were prepared to be used as reference (hereafter referred generically as control cells).

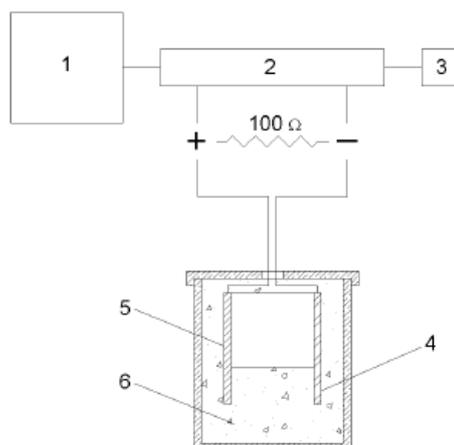
Figure 2. Schematic representation of assembled two electrodes cell. Legend: 1. PC; 2. Datataker; 3. Power supply; 4 and 5. Working and counter electrodes, respectively; 6. Mortar.

To assemble the electrochemical cells used to measure i_{gal} , 120±10 g of fresh mortar was transferred to each 100 mL PE flask where the electrodes were immersed and the flask closed (mortar was prepared according to section 2.3 and immediately used). Using an automatic data acquisition system (Datataker DT505, series 3), the i_{gal} measurement of the prepared cells were performed through reading the potential difference to the terminals (shunted with a 100 Ω

resistor *vide* Fig. 2) immediately after being embedded in fresh mortar. Measurements were performed with a periodicity of 1 minute at the first seven days, and at each 5 minutes during the remaining time until the record was completed, at the 74th day.

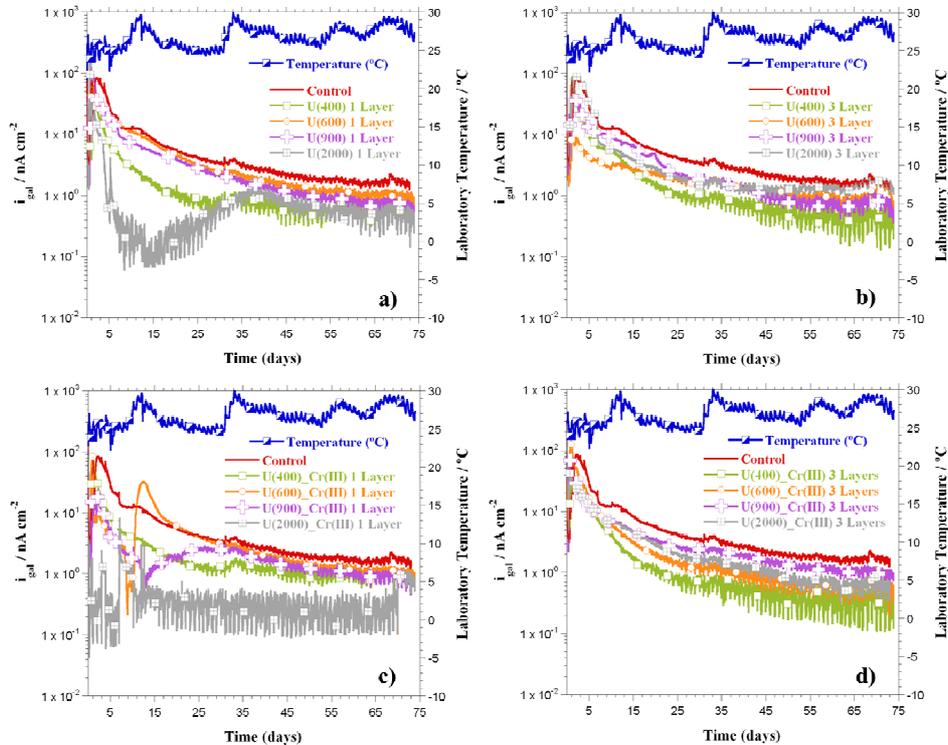
Figure 3. Recorded galvanic current profiles.

Fig. 3 shows the macrocell current density (i_{gal}) response collected from the different prepared electrochemical cells involving the HDGS coated samples and the control cell during 74 days [30].

The high values of i_{gal} recorded for the first days of contact with the fresh mortar are due to zinc corrosion, that in the presence of high alkaline environments it corrodes [9-15]. Nevertheless, the coated samples tend to lower values when compared to control sample. The obtained evolution of cell current density with time shows a profile that is dependent on OIH coating matrix, the presence of Cr(III) ions and the number of dipping steps. Globally the measured current

density decreases along the contact time showing in the 74th day an average value that is about two orders of magnitude lower than the initially observed. Cells based on one layer coated HDGS samples reveal a very noisy behavior comparatively with samples with a coating produced by three dipping steps.

As shown, the i_{gal} cell values are sensitive to the external laboratory temperature variation and to the composition and number of OIH deposited (one and three) layers. The collected data make possible to distinguish between the different used OIH coatings as the output response changes with the coating composition and with the presence or absence of inhibitor (Cr(III)). It was also observed that the uncoated HDGS specimen shows the higher current density values among the all set of tested macrocells.

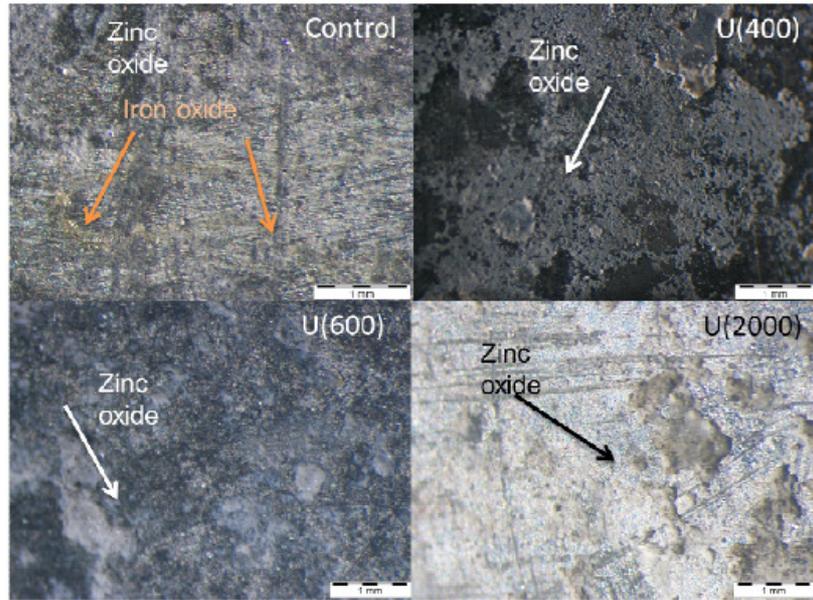
Figure 4. Observation of HDGS surfaces uncoated (control) and coated with OIH sol-gel with stereomicroscope after being embedded in mortar for 74 days, showing the presece of zinc oxide and traces of iron oxides.

Fig. 4 shows the images obtained with a stereomicroscope for the uncoated HDGS (control) and for HDGS coated by one dip step for U(400), U(600) and U(2000). The stereomicroscope images that show to be less attacked by the electrolyte correspond to cells where lower values of i_{gal} data were recorded.

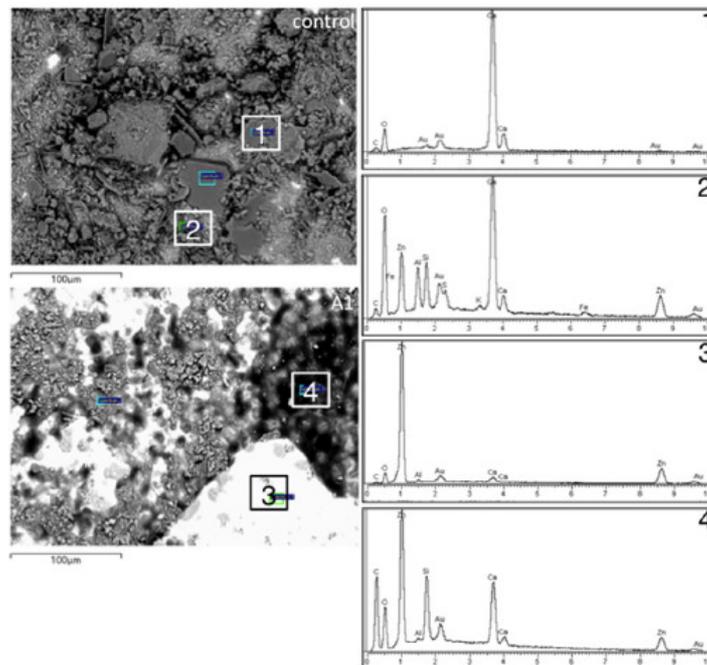
Figure 5. BSE images of the HDGS samples surface for control and HDGS coated with U(400) after being embedded in mortar for 74 days with the localization of the EDS spectra; 1, 2 EDS spectra for control; 3 and 4 EDS spectra for HDGS coated with U(400).

Fig. 5 shows the SEM images and EDS spectra obtained for the control and for HDGS coated with U(400) by one dip step.

From the analysis of the collected set of images obtained by SEM, it can be concluded that the surface of uncoated HDGS sample (control cell) reveals the most severe damages among all that were exposed to mortar. The obtained results from EDS analysis reveal the presence of iron peaks. These results are in agreement with i_{gal} data and with stereomicroscope images.

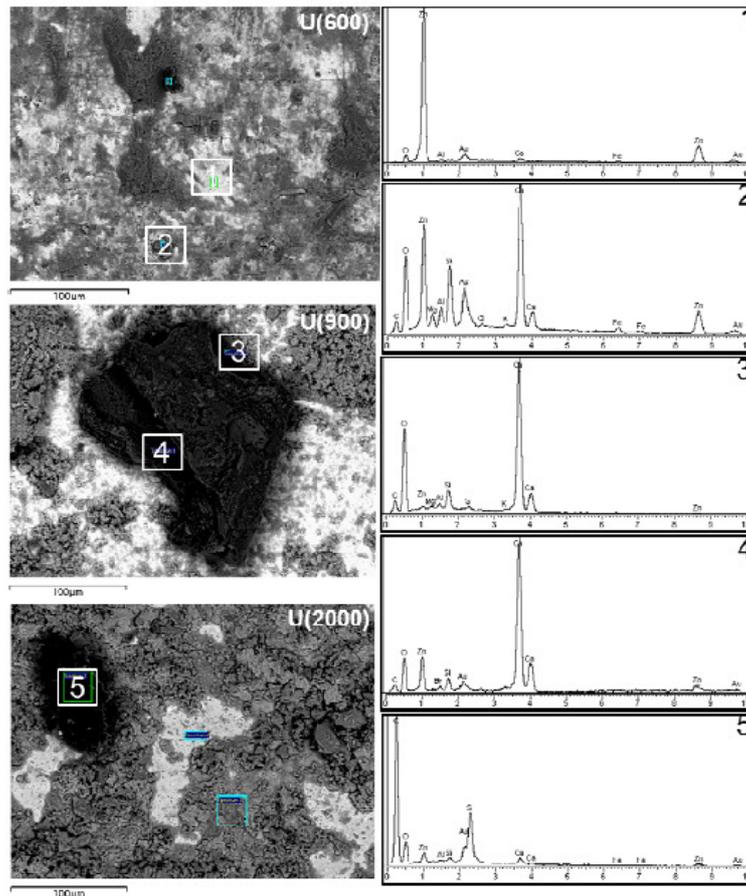
Figure 6. BSE images of the HDGS samples surface coated with U(600), U(900) and U(2000) after being embedded in mortar for 74 days with the localization of the EDS spectra; 1, 2 EDS spectra for HDGS coated with U(600); 3 and 4 EDS spectra for HDGS coated with U(900); 5 EDS spectrum for HDGS coated with U(2000).

Fig. 6 shows the SEM images and EDS spectra obtained for HDGS coated with U(600), U(900) and U(2000) by one dip step.
